Characterizing GEO Titan Transtage Fragmentations using Ground-based Measurements

H. Cowardin¹ and P. Anz-Meador²

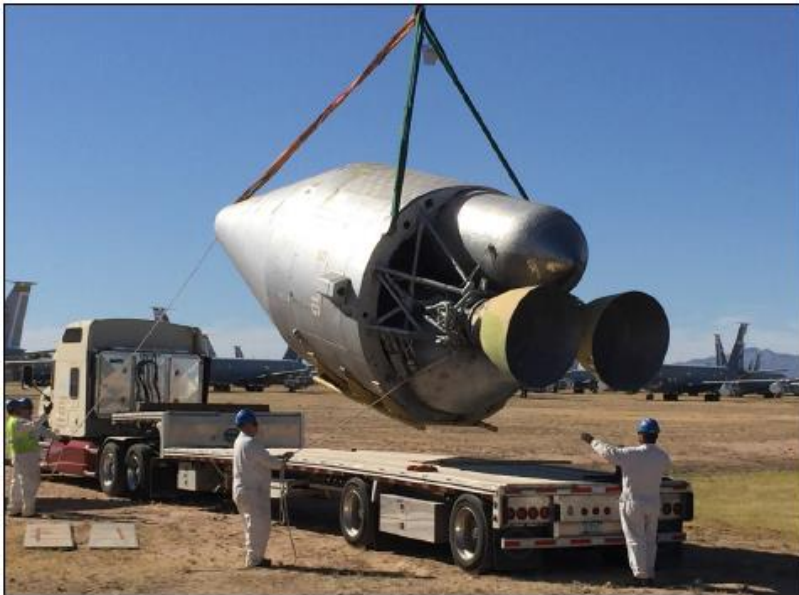
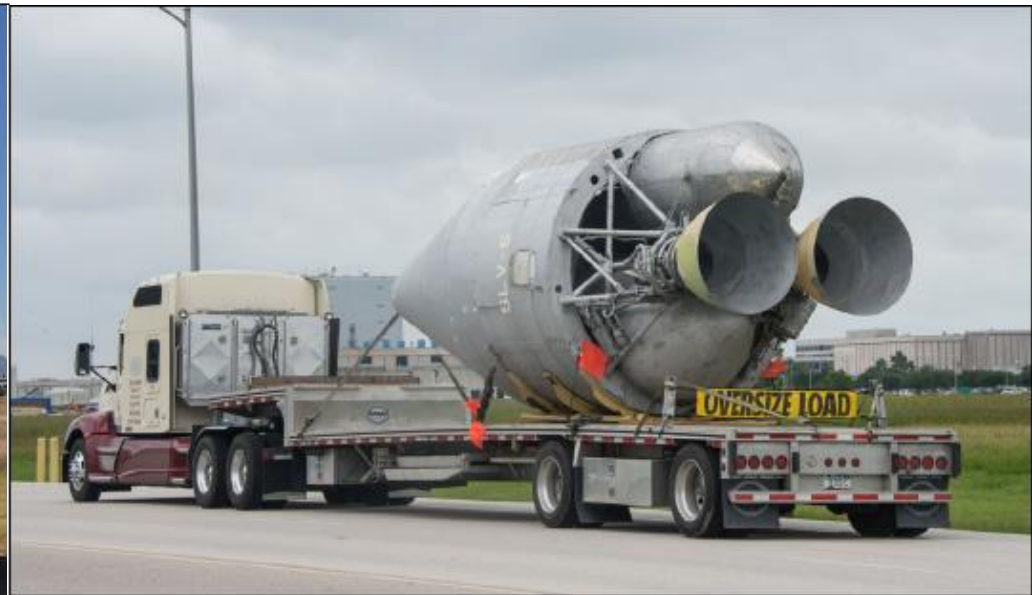
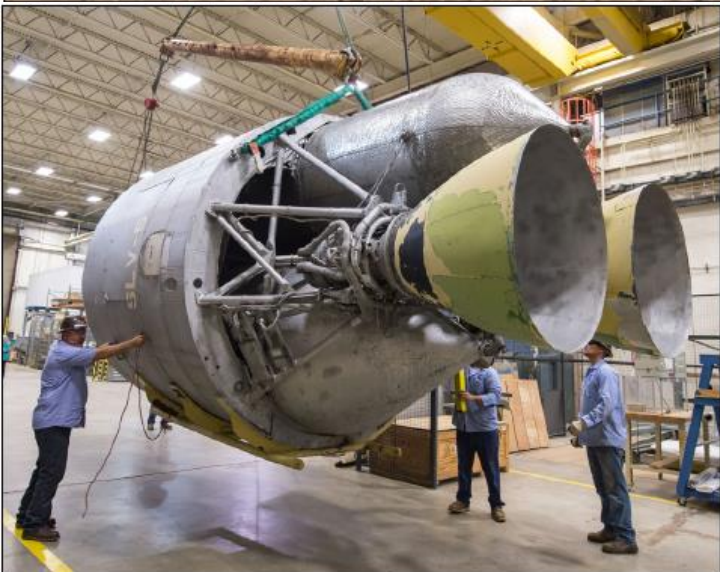
Transport Pictures

- 1) The Titan Transtage is lifted onto a tractor-trailer for transport to NASA JSC. (Image courtesy of Rob Raine, U.S. Air Force 309th Aerospace Maintenance and Regeneration Group).
- 2) The Titan Transtage arrives at JSC after a road journey shared with curious drivers. The 18-wheeler was detained going through Houston by a curious sheriff who said "You aren't doing anything wrong. I just wanted to see what this thing was." (Image credit: NASA/David DeHoyos).
- 3) NASA JSC team members maneuver the Titan Transtage into a holding cradle in B9S. (Image credit: NASA/David DeHoyos).

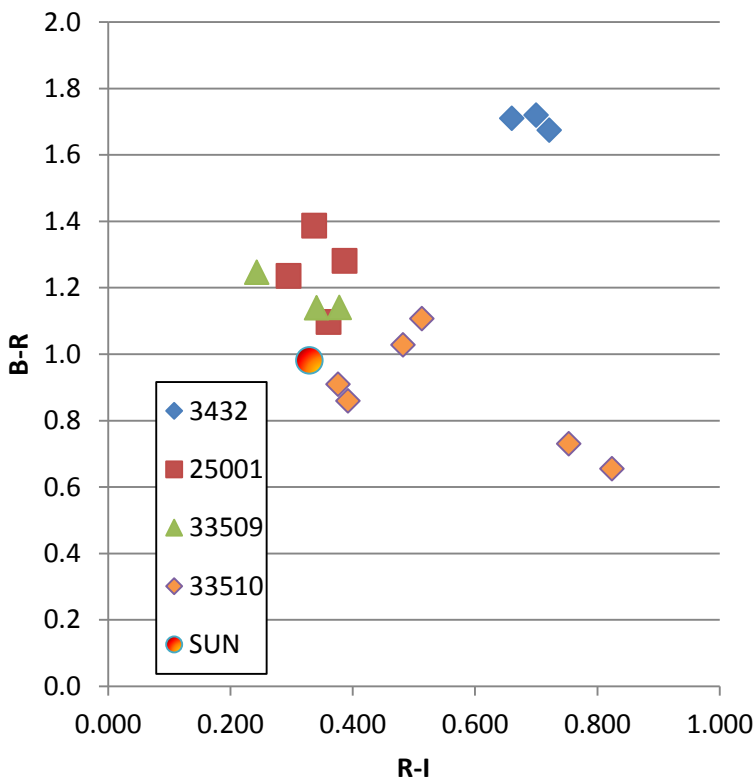
- Data acquired using the CTIO 0.9-m telescope in Chile using Johnson/Kron-Cousins B, V, R, and I filters (Five exposures in each filter)
- Calibrated R magnitude data and color index data with respective photometric 1-sigma errors

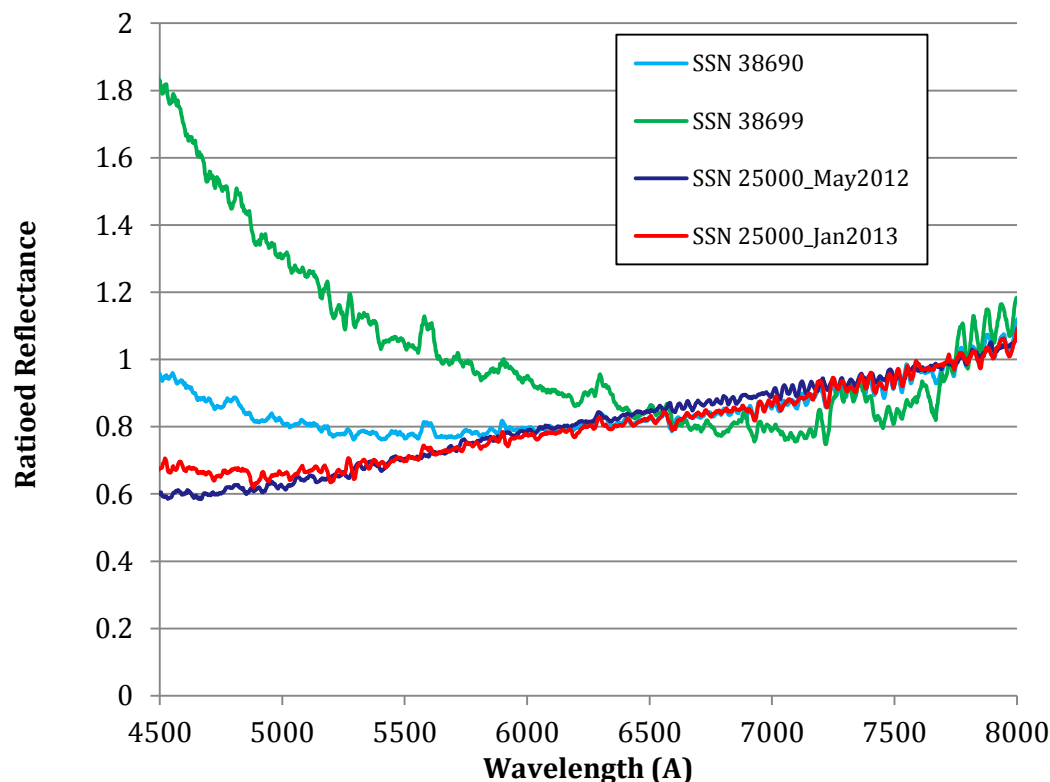
- Data acquired using Las Campanas 6.5-m Clay Magellan Telescope in Chile, using Low Dispersion Survey Spectrograph (Version 3) covers 4000-8000 Angstroms (\AA)
- Normalized to one using an average value from 7500-8000 \AA

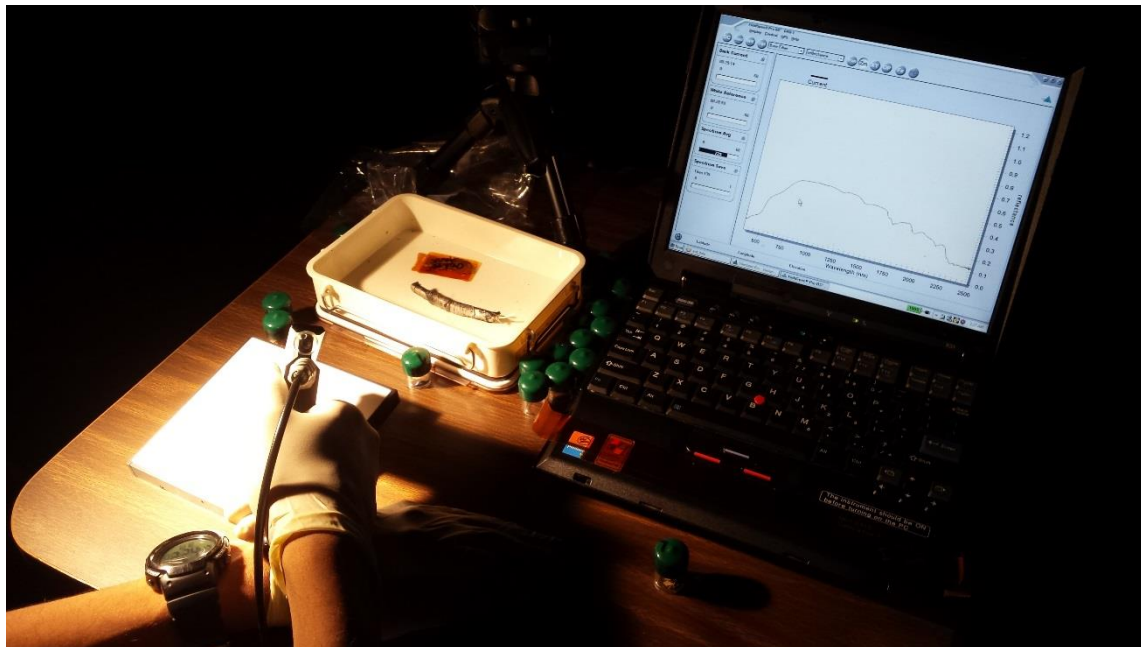
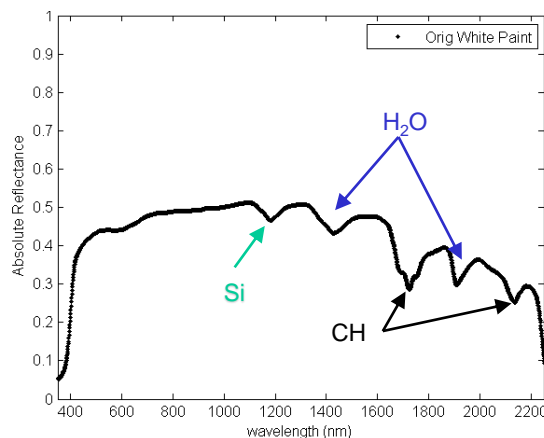
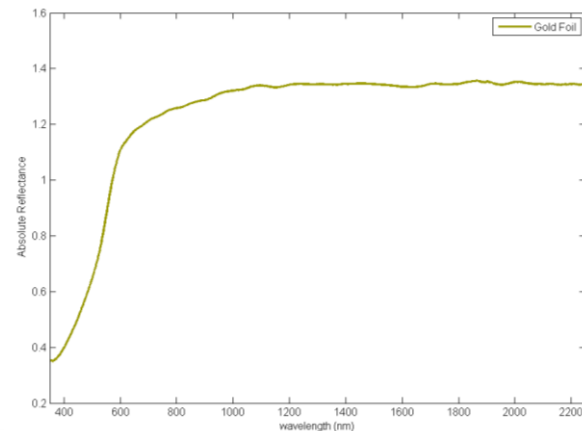
Spectral Data Analysis from Material Samples Collected from AMARG

- 001 Wire Retention Netting
- 002 Silver Foil
- 003 Green Paint Right
- 004 Yellow Paint Right
- 005 Gold Foil
- 006 "L" SLV-5 Paint
- 007 Insulating Tape R
- 008 Fuel Tank Wire
- 009 White Paint Checkerboard from Sandpaper
- 010 Silver Paint Checkerboard from Sandpaper
- 011 Fiber Matt
- 012 Fiber Matt
- 013 Blue Paint
- 014 Yellow Paint
- 015 Metal Tag
- 016 Aluminum Metal
- 017 Rubber
- 018 Attitude Control
- 019 Painted Screw
- 020 Right Primer
- 021 Left Green Paint
- 022 Left Yellow Paint
- 023 Orig White Paint
- 024 Exterior Red Paint
- 025 Left Blue Paint
- 026 Plastic Container - Control
- 027 Oxidizer Tank
- 028 Copper Wire
